Case study no. 13

SPORT HALL ROGLA

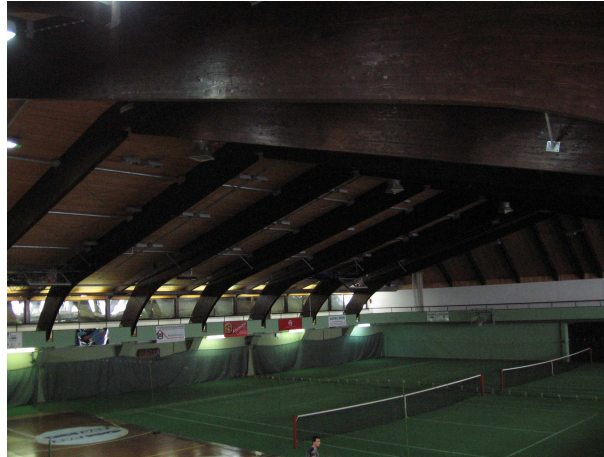
Fig. 1: Inside photo of the hall.

The main structure bearing system consists of 10 glue-laminated arch beams which are placed on a constant distance of 5 meters. The beams of the overall span of 35.2 meters are supported with rigid reinforced concrete foundations (*Fig. 1*). The overall ground-plan dimensions of the hall are 40.40 x 45.35 m², total floor area A = 1832.14 m².

As presented in *Fig. 1* the building is very undisturbing incorporated in a beautiful green Pohorje mountain landscape. Additionally, timber is a healthy natural material and is consequently particularly desired for sports activities.

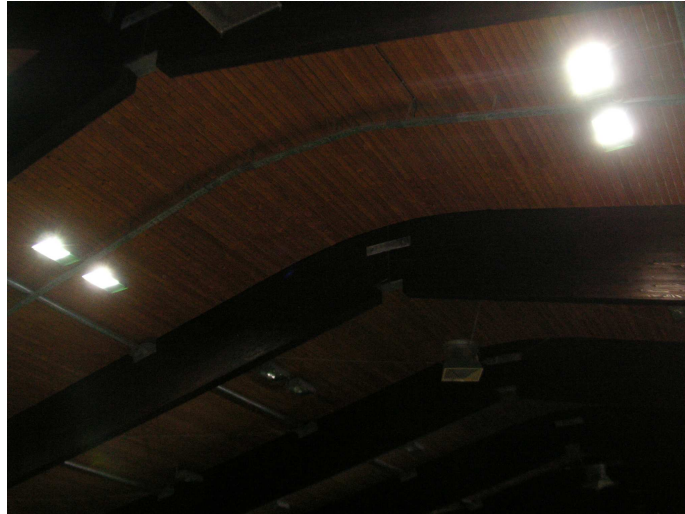
Fig. 8: A hinge connection between two curved beam elements.

The foundations were built completely classical with a reinforced concrete of a strength class C30/37 and steel class S400. The glue-laminated beams of a half of total span (17.60 m) were produced in company Hoja and then transported to the building-site. The both parts were connected together as a hinge connection, as presented in Fig.8 (for details see Section 8).

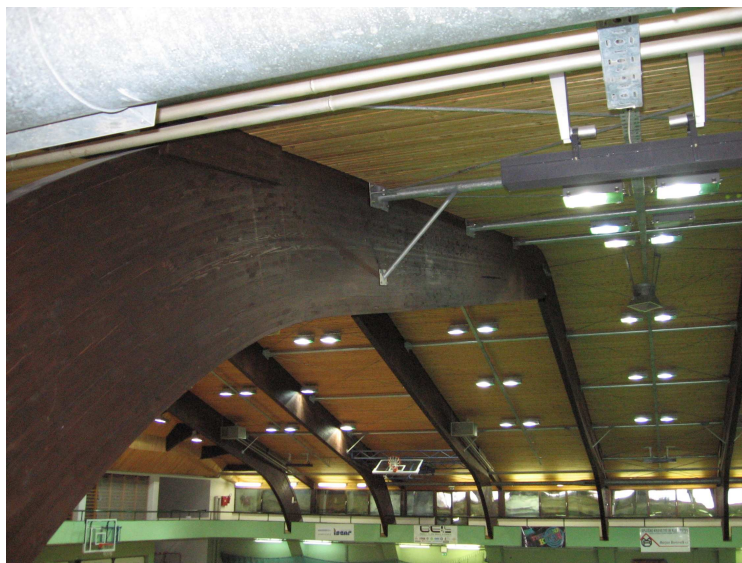
Fig. 11: A steel bracing system in the upper horizontal beam plane.

To assure a horizontal protection of the building a classical bracing system using steel diagonals were built in the upper horizontal plane of the curved beam element (*Fig. 11*).

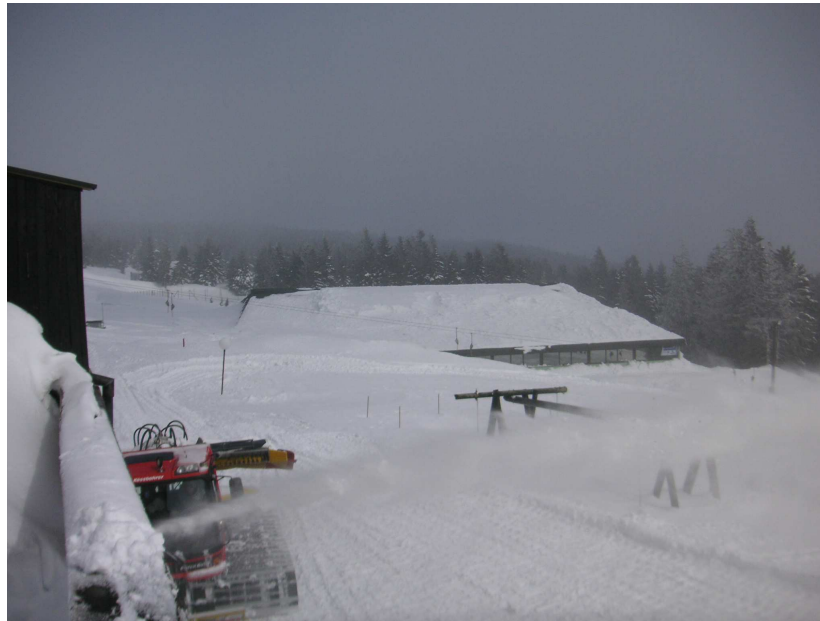
Fig. 12: A heavy snow in April 2006.

In April 2006 a heavy snow of a total height of 2.50 meter fall (*Fig. 12*). Therefore, the snow load was bigger as it was predicted in the statically analysis (3.75 kN/m^2) using at that time valid Slovenian codes.

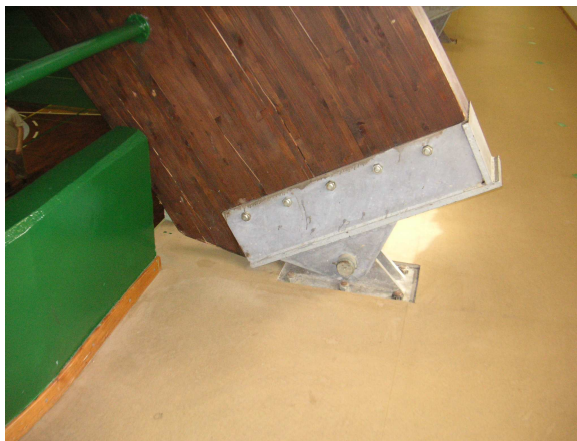
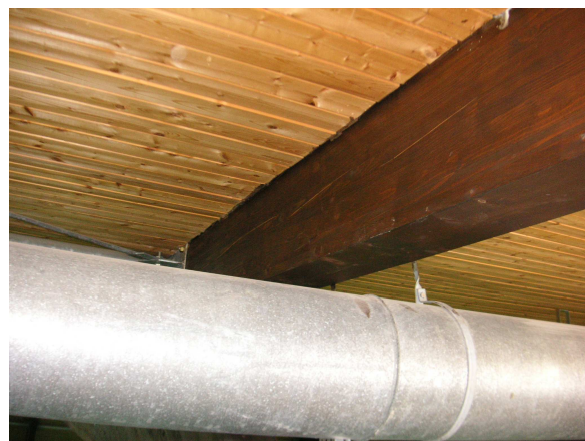
Fig. 13: Cracks by the connection to the base (a) and in the middle hinge (b).

Because the snow load was not symmetrically distributed on the roof, some cracks appeared in the timber beams close to a base connection (*Fig. 13a*) and around the middle hinge (*Fig. 13 b*).

Because of that a special project for reconstruction of the main timber beam element was done (Dobriša, Premrov) inserting a special plywood board in the middle of the beam span (*Fig. 14*). Additionally, a special analysis was made to calculate the maximal permitted snow load for the actual dimensions of the main timber bearing capacity beam element.
